# Endodontics and Neurovascular Injury

Fall 2021

## ENDODONTICS: Colleagues for Excellence

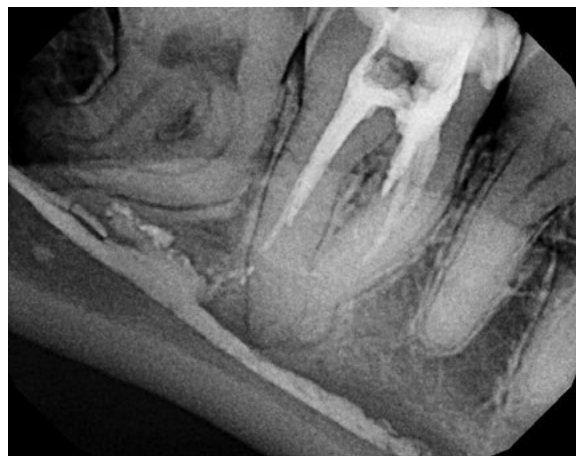
**Figure 1.** The highly complex anatomy on this lower molar in conjunction with poor clinical skills has resulted in a perforated canal. The clinician's desire to deliver the calcium hydroxide down to the apices utilizing a needle delivery, has combined to create an extreme and negligent overfill into the IAN that will affect this female patient for the rest of her life.

to the IANC; and/or a chemical injury from obturation material or intracanal medication, specifically endodontic sealers (or cement) or calcium hydroxide. (Figure 1)

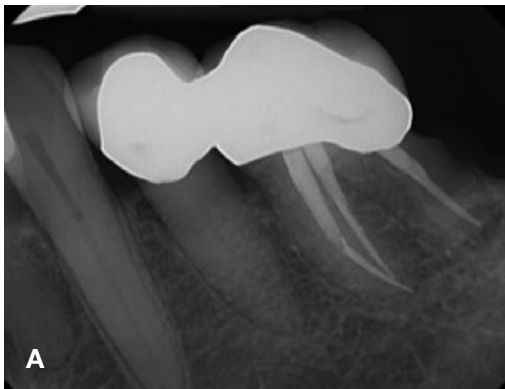
**Figure 2A.** Tooth number #20. Dentist attempted access on a highly mineralized tooth.

It can allow easier flow of potentially cytotoxic irrigants (such as sodium hypochlorite) into the periapical tissues and into the IANC, especially if syringe usage and significant positive pressure is applied for delivery of the irrigant. (Figure 2a, b, c) The result can be profound tissue damage and necrosis and a resulting IAN injury. Further, the over-instrumentation of the apical foramen or extrusion through a perforation can create an open passageway for root canal obturation material to enter the periapical tissues and IANC. Whereas an over-extended gutta percha cone (or an obturator) can cause mechanical injury to the IAN as well as local edema-pressure to the nerve (Figure 3), the over-extension of endodontic sealer can cause a chemical burn of the neural tissues and immediate damage. (23) In a recent study of CBCT images, the mandibular canal was seen positioned directly below the molar and second bicuspid roots approximately 50% of the time. (12). The clinician should be aware that root canal sealers typically contain zinc oxide and eugenol, and often calcium hydroxide. In any formulation, calcium hydroxide can be very alkaline. Even the newer bioceramic sealers contain calcium hydroxide in their unset states. All these high pH materials, when in contact with the inferior alveolar nerve, can cause a gradual and persistent insult to the IAN leading to a neuropathy. Left undetected, unmanaged, or ignored by waiting to monitor symptoms, these materials can cause irreversible paresthesia, anesthesia, or dysesthesia, depending on the length of time they are in contact with the neural bundle and the quantities that are over-extended into the IANC.

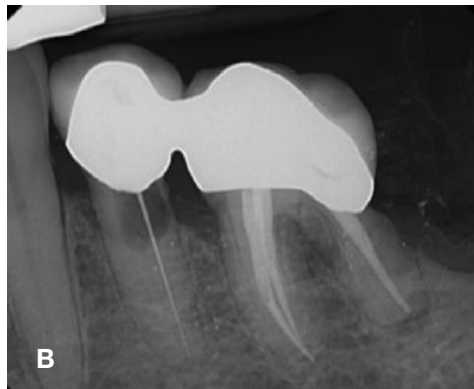
**Figure 2B.** Access perforated the facial of the tooth below the crestal bone and the dentist believing that the pulp was exposed, irrigated aggressively causing hypochlorite extrusion and neurologic trauma to the mental nerve. Notice the off-centered position of the measurement file.

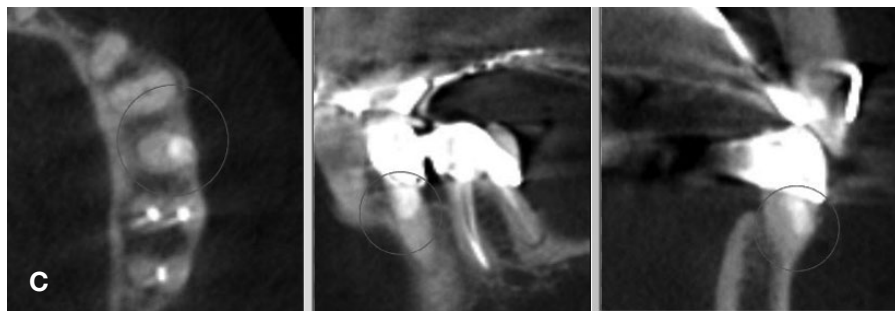
**Figure 2C.** CBCT imaging demonstrating the perforation and the access orientation.

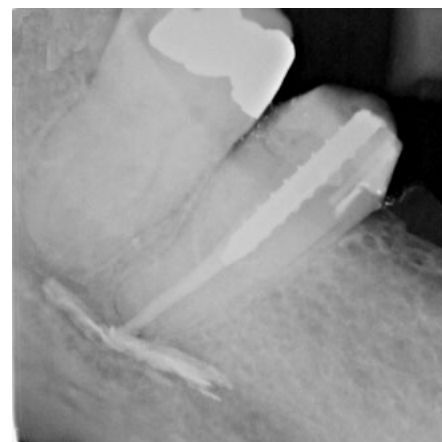
**Figure 3.** This IAN overfill was the result of a gutta-percha carrier taken from a heated oven and placed with too much sealer and too much apical force into an apical diameter that was over-instrumented and very large. The resulting overfill was a combination of the operator believing that a gutta percha carrier offered a simple technique and was unaware that the hydraulics of the fill and an over-instrumented apex could result in an extreme overfill, severely injuring this female patient.

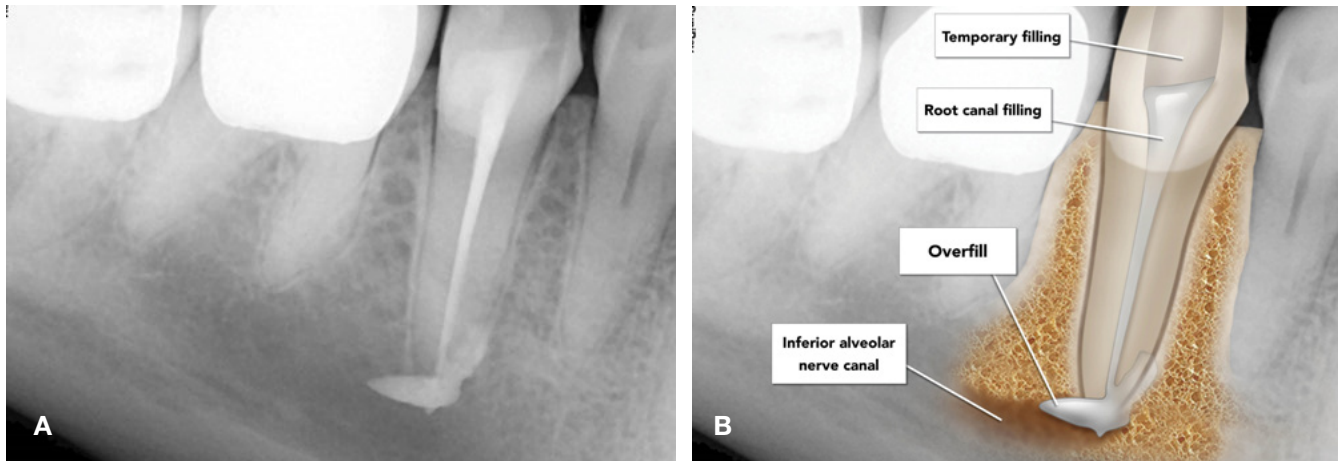
**Figures 4A-B.** Radiograph demonstrates the intimate relationship of the terminus in this lower bicuspid to the mental foramen. A watch and wait strategy by the practitioner resulted in permanent neurologic deficits to this female patient. The artist's drawing below the radiograph, was used at trial by the plaintiff's legal counsel, to inform the jury regarding the radiographic images.

Many clinicians have an informed consent form for their patients to sign prior to treatment. For endodontic treatment, often there is language that states: "lip or chin numbness may occur following endodontic treatment, which may be temporary or in rare instances may become permanent." Although the clinician (and the patient) may believe this absolves any possible litigation from an IAN injury, this may be a false sense of security. Informed consent, whether in the dental practice or in any aspect of medical treatment, may not apply in the event of negligence. It has been successfully argued in many court cases that the clinician cannot expect the patient to waive their right to competent treatment. As such, the question becomes: "when IAN damage occurs from over-filling into the IANC, can it ever occur without negligence?" When argued effectively by the plaintiff, there have been numerous cases whereby the informed consent has not been permitted to be used as a defense in these legal cases. (Figure 4)

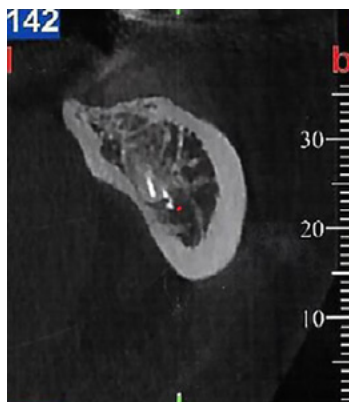
**Figure 2.** CBCT DICOM image 142 shows a single drop of sealer in proximity of IAN (marked with red dot).

A CBCT was taken during the course of discovery, and it was determined that there was a single slice in the DICOM imaging format that demonstrated a single microscopic “pinhead” of sealer on slice 142 of the scan. This extremely small amount of sealer adjacent to, **but not inside the IAN**, was capable of creating a chemical source of inflammation inside the fascicles of the IAN to interrupt signal transmission for this patient.
