# Endodontics and Neurovascular Injury

Fall 2021

## ENDODONTICS: Colleagues for Excellence

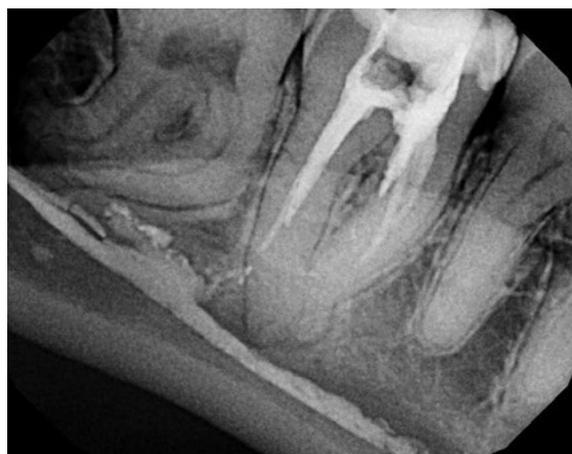
**Figure 1.** The highly complex anatomy on this lower molar in conjunction with poor clinical skills has resulted in a perforated canal. The clinician's desire to deliver the calcium hydroxide down to the apices utilizing a needle delivery, has combined to create an extreme and negligent overfill into the IAN that will affect this female patient for the rest of her life.

to the IANC; and/or a chemical injury from obturation material or intracanal medication, specifically endodontic sealers (or cement) or calcium hydroxide. (Figure 1)

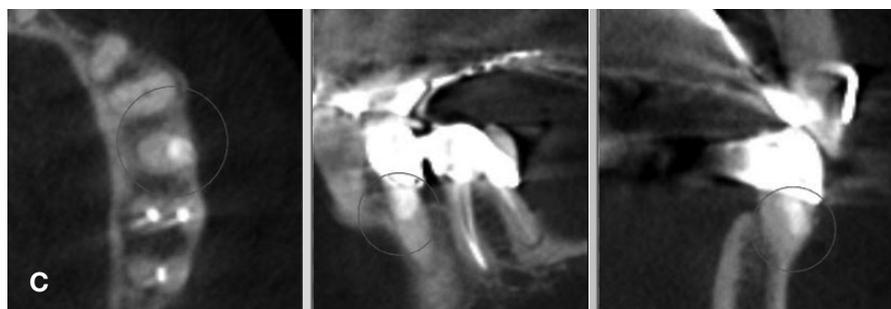
**Figure 2C.** CBCT imaging demonstrating the perforation and the access orientation.

It can allow easier flow of potentially cytotoxic irrigants (such as sodium hypochlorite) into the periapical tissues and into the IANC, especially if syringe usage and significant positive pressure is applied for delivery of the irrigant. (Figure 2a, b, c) The result can be profound tissue damage and necrosis and a resulting IAN injury. Further, the over-instrumentation of the apical foramen or extrusion through a perforation can create an open passageway for root canal obturation material to enter the periapical tissues and IANC. Whereas an over-extended gutta percha cone (or an obturator) can cause mechanical injury to the IAN as well as local edema-pressure to the nerve (Figure 3), the over-extension of endodontic sealer can cause a chemical burn of the neural tissues and immediate damage. (23) In a recent study of CBCT images, the mandibular canal was seen positioned directly below the molar and second bicuspid roots approximately 50% of the time. (12). The clinician should be aware that root canal sealers typically contain zinc oxide and eugenol, and often calcium hydroxide. In any formulation, calcium hydroxide can be very alkaline. Even the newer bioceramic sealers contain calcium hydroxide in their unset states. All these high pH materials, when in contact with the inferior alveolar nerve, can cause a gradual and persistent insult to the IAN leading to a neuropathy. Left undetected, unmanaged, or ignored by waiting to monitor symptoms, these materials can cause irreversible paresthesia, anesthesia, or dysesthesia, depending on the length of time they are in contact with the neural bundle and the quantities that are over-extended into the IANC.
